**DEPARTMENT OF TRANSPORTATION****DIVISION OF ENGINEERING SERVICES**

Contract #: 04-0120F4Cty: SF/ALA Rte: 80 PM: 13.2/13.9File #: 1.28**WELDING INSPECTION REPORT****Resident Engineer:**Siegenthaler, Peter**Address:** 333 Burma Road**City:** Oakland, CA 94607**Report No:** WIR-026192**Date Inspected:** 25-Aug-2011**Project Name:** SAS Superstructure**OSM Arrival Time:** 700**Prime Contractor:** American Bridge/Fluor Enterprises, a JV**OSM Departure Time:** 1730**Contractor:** American Bridge/Fluor Enterprises, a JV**Location:** Job Site**CWI Name:** John Pagliero**CWI Present:** Yes No**Inspected CWI report:** Yes No N/A**Rod Oven in Use:** Yes No N/A**Electrode to specification:** Yes No N/A**Weld Procedures Followed:** Yes No N/A**Qualified Welders:** Yes No N/A**Verified Joint Fit-up:** Yes No N/A**Approved Drawings:** Yes No N/A**Approved WPS:** Yes No N/A**Delayed / Cancelled:** Yes No N/A**Bridge No:** 34-0006**Component:** SAS Tower**Summary of Items Observed:**

**A). Tower Shear Plates**

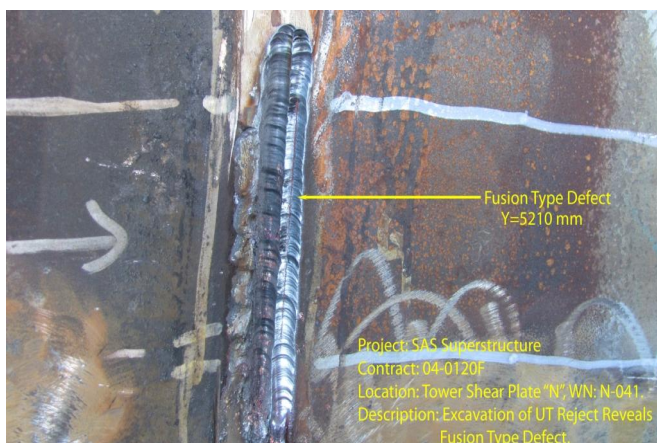
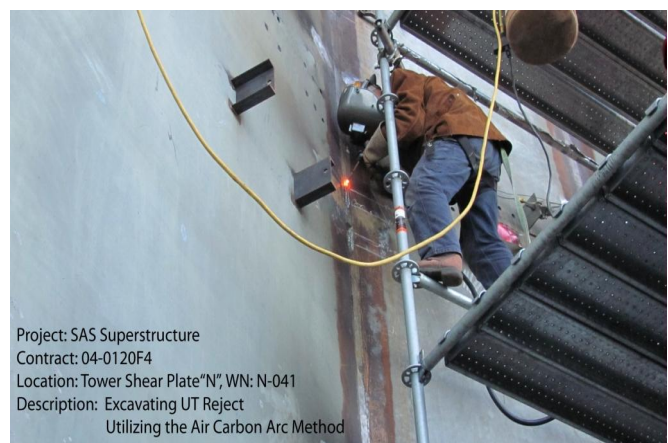
The digital photographs below illustrate some of the work observed during this scheduled work date.
